RVTD Operations, Administration & Maintenance Campus Master Plan Report *DRAFT*

02.19.2021

Rogue Valley Transportation District Existing Conditions Assessment

October 09, 2020

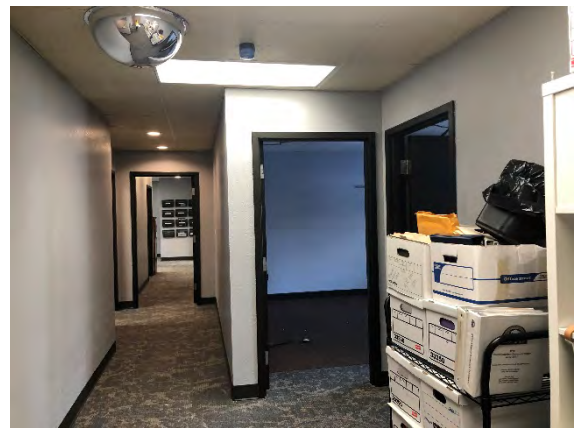
Main Hallway

Interior finishes include some newly carpeted areas in the roughly half of the hallway, offices, and the board room, which are in excellent condition from being installed within the last year. Other Vinyl tile flooring in the restrooms and breakroom appear to be from a remodel in the 80's and are showing wear consistent with their age and use. The western half of office building ceiling areas are gypsum board and the remaining ceilings in the office are acoustic tile. No noticeable water stains were present in the ceilings, and the acoustic tile ceilings show wear consistent with their age. The eastern side of the office included a recent addition of a board room and 3 office rooms, doors, finishes, and ceilings in these spaces are in excellent condition.

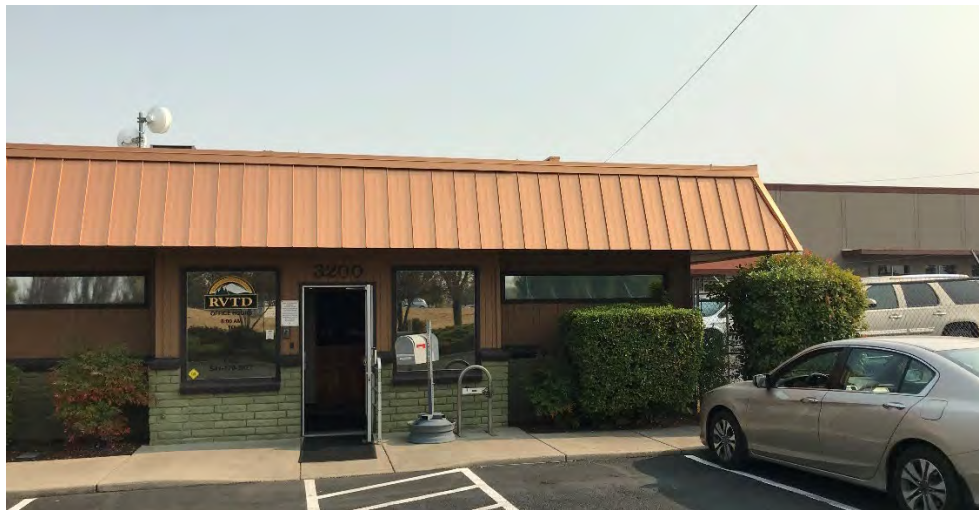
Admin Office – Main Entrance

The exterior of the building is constructed primarily of wood stud walls with R-19 batt insulation and painted cedar siding, above masonry veneer base. Overall, the exterior of the building appears to be in good condition. There are a few minor areas of dry rot at the base of the wood siding on the east portion of the warehouse building. Our observations were limited to a visual inspection of the interior and exterior conditions and did not include any destructive testing or investigation to determine the conditions of the wall cavities. The roofing systems consist of low slope single-ply PVC and roof drains tied to the underground stormwater system. Mansard roofs wrap the perimeter of the front office area and are roofed with standing seam metal roofing. It appears to be well maintained and in good condition.

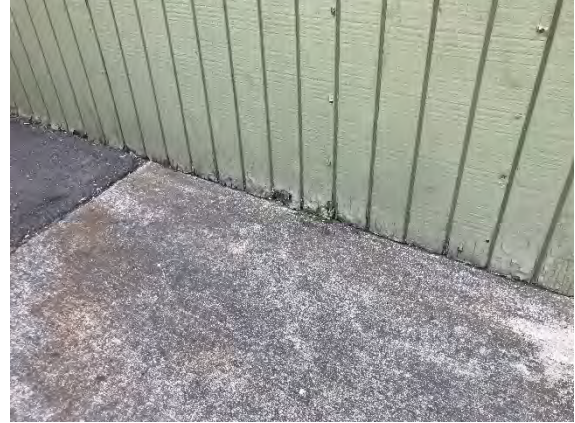
Worn siding (east side)

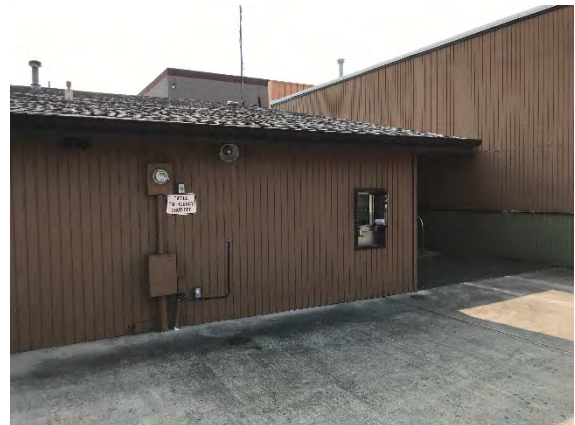
Operations North side

The Operations office building is roughly 1,370 sf and constructed at an unknown year. The building has had an addition to the north side and interior renovations since originally constructed. Interior finishes range from carpet, vinyl flooring, suspended acoustic tile ceilings, and painted drywall. Finishes show typical wear for their age and in need of replacement. Several areas of existing vinyl flooring are worn and should be replaced. Doors are hollow metal with steel frames, in good condition. Exterior wood siding is worn and appears to have some drainage issues on the west side of the building.

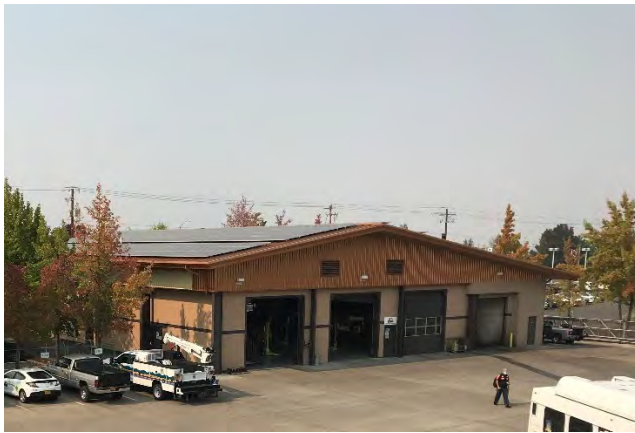
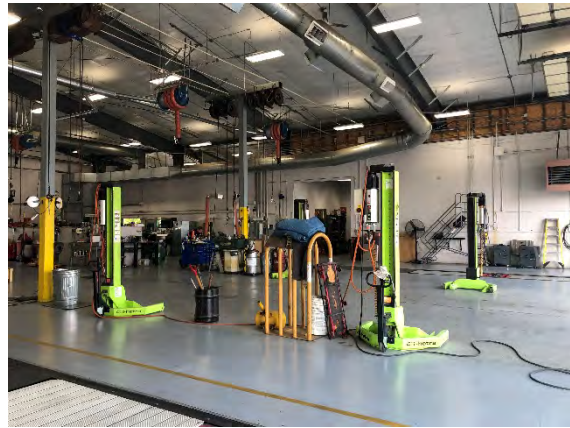
Fleet Maintenance - eastern face

The Fleet maintenance building was observed for general conditions. The original date of construction is unknown but there were remodels completed in 1989 and 2009. The most recent remodel added an exterior column structure and roof around the existing unreinforced masonry walls.

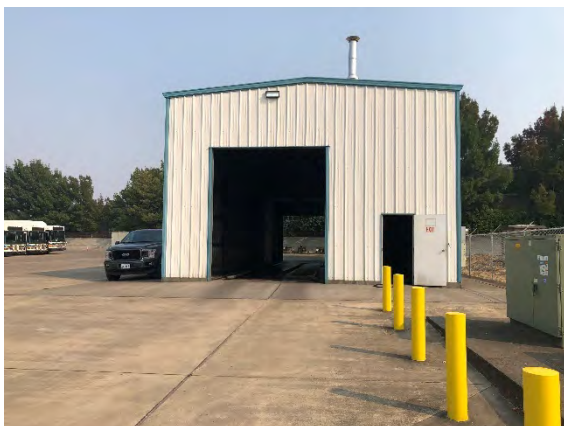
West Face of Bus Wash

The Bus Washing building is a manufactured steel building. The exterior envelope is steel panel siding in good condition. The run-off from the bus washing process is unfiltered and drains into the sanitary sewer system which does not meet current code requirements.

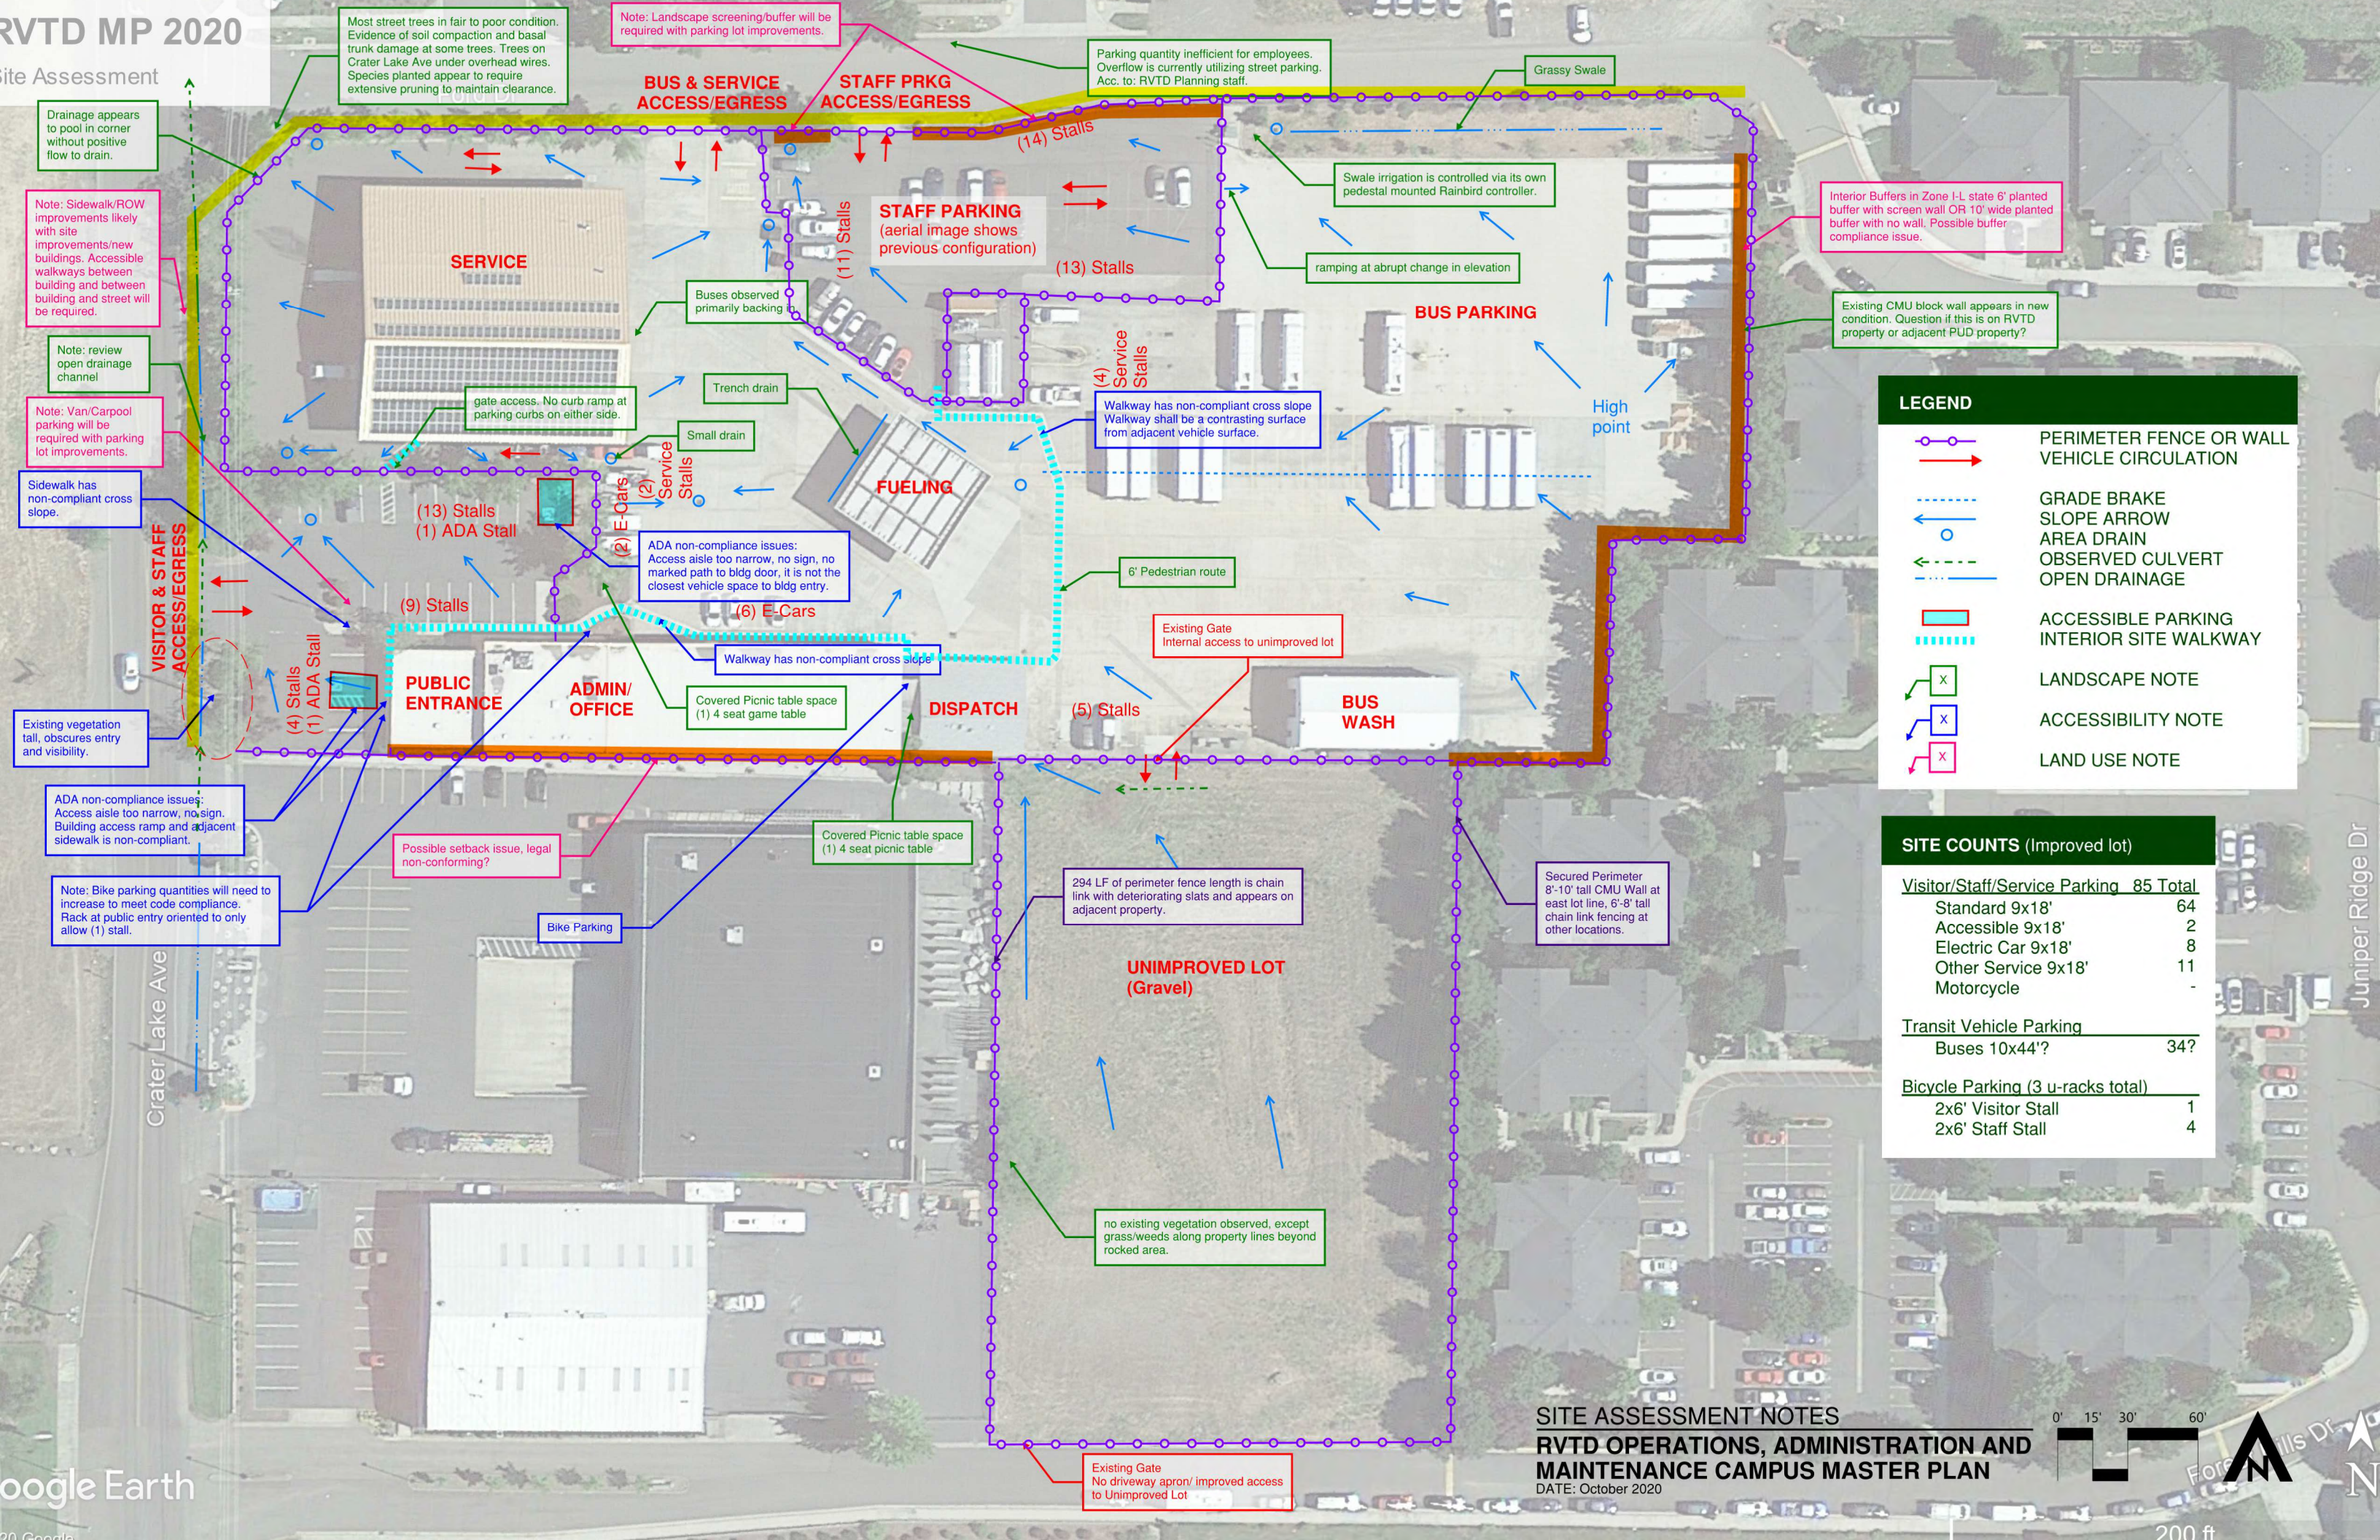
Drainage appears to pool in corner without positive flow to drain.

Note: Sidewalk/ROW improvements/new buildings. Accessible walkways between building and between building and street will be required.
