RVTD Operations, Administration & Maintenance Campus Master Plan Report *Phase I*

Rogue Valley Transportation District Existing Conditions Assessment

October 09, 2020

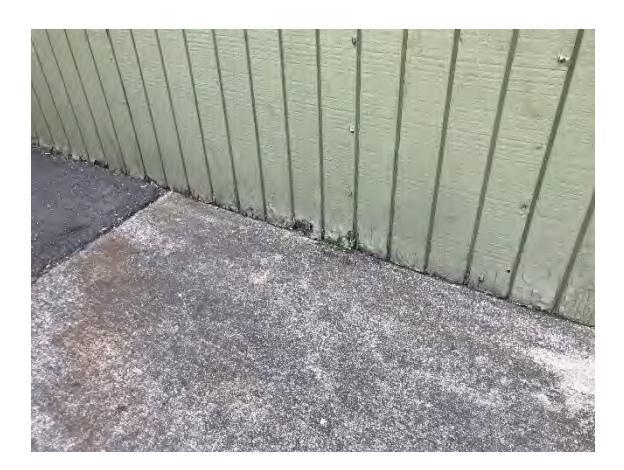
Worn siding (east side)

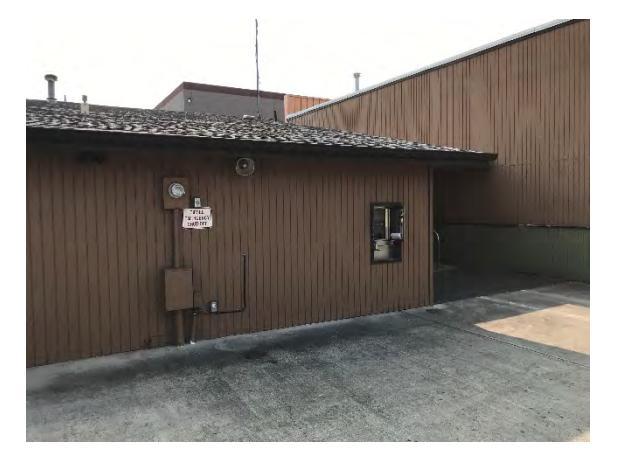
Operations North side

The Operations office building is roughly 1,370 sf and constructed at an unknown year. The building has had an addition to the north side and interior renovations since originally constructed. Interior finishes range from carpet, vinyl flooring, suspended acoustic tile ceilings, and painted drywall. Finishes show typical wear for their age and in need of replacement. Several areas of existing vinyl flooring are worn and should be replaced. Doors are hollow metal with steel frames, in good condition. Exterior wood siding is worn and appears to have some drainage issues on the west side of the building.

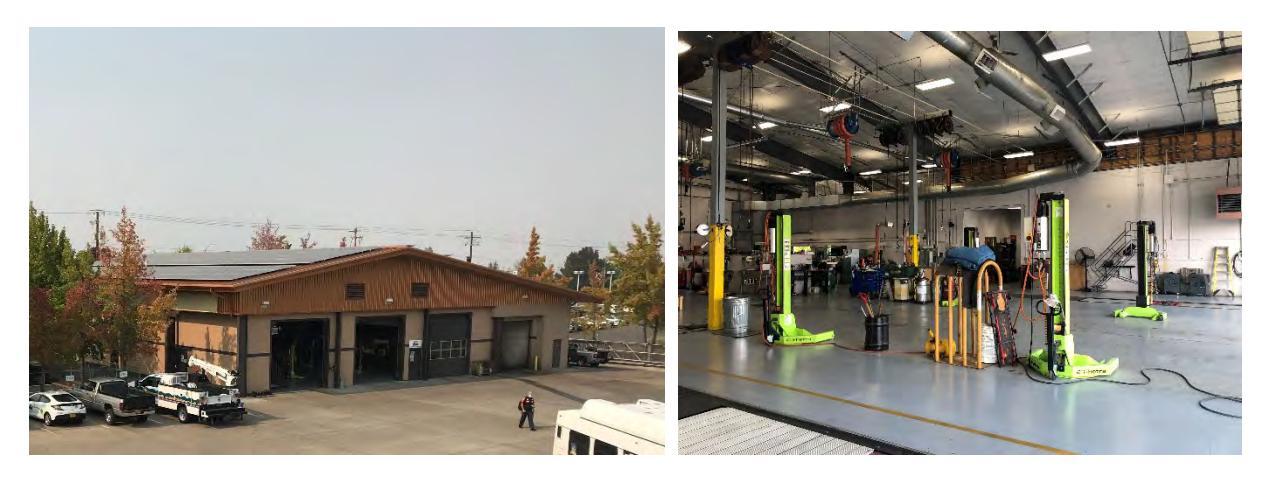
Fleet Maintenance - eastern face

The Fleet maintenance building was observed for general conditions. The original date of construction is unknown but there were remodels completed in 1989 and 2009. The most recent remodel added an exterior column structure and roof around the existing unreinforced masonry walls.

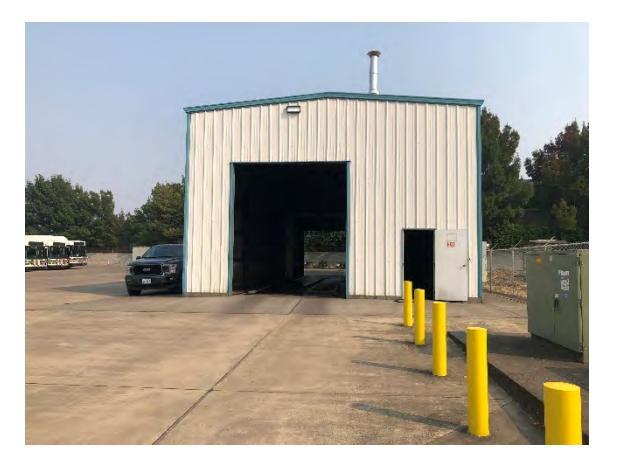
West Face of Bus Wash

The Bus Washing building is a manufactured steel building. The exterior envelope is steel panel siding in good condition. The run-off from the bus washing process is unfiltered and drains into the sanitary sewer system which does not meet current code requirements.
