RVTD Operations, Administration & Maintenance Campus Master Plan Report *Phase I*

Rogue Valley Transportation District Existing Conditions Assessment

October 09, 2020

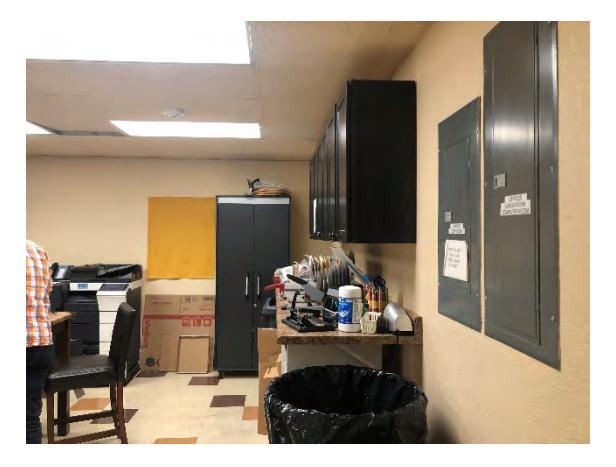
Breakroom

Interior finishes include some newly carpeted areas in the roughly half of the hallway, offices, and the board room, which are in excellent condition from being installed within the last year. Other Vinyl tile flooring in the restrooms and breakroom appear to be from a remodel in the 80's and are showing wear consistent with their age and use. The western half of office building ceiling areas are gypsum board and the remaining ceilings in the office are acoustic tile. No noticeable water stains were present in the ceilings, and the acoustic tile ceilings show wear consistent with their age. The eastern side of the office included a recent addition of a board room and 3 office rooms, doors, finishes, and ceilings in these spaces are in excellent condition.

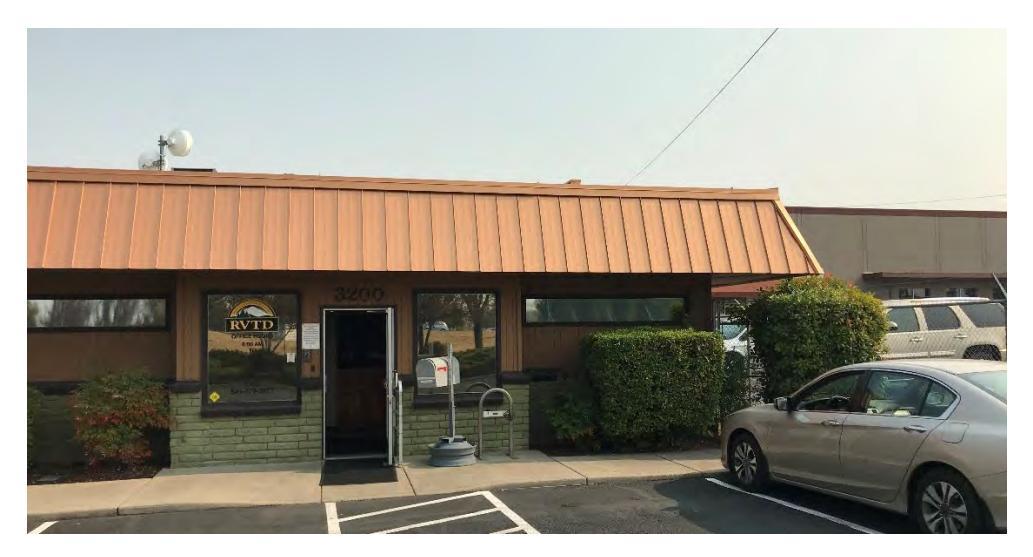
Admin Office – Main Entrance

The exterior of the building is constructed primarily of wood stud walls with R-19 batt insulation and painted cedar siding, above masonry veneer base. Overall, the exterior of the building appears to be in good condition. There a few minor areas of dry rot at the base of the wood siding on the east portion of the warehouse building. Our observations were limited to a visual inspection of the interior and exterior conditions and did not include any destructive testing or investigation to determine the conditions of the wall cavities. The roofing systems consist of low slope single-ply PVC and roof drains tied to the underground stormwater system. Mansard roofs wrap the perimeter of the front office area and are roofed with standing seam metal roofing. It appears to be well maintained and in good condition.

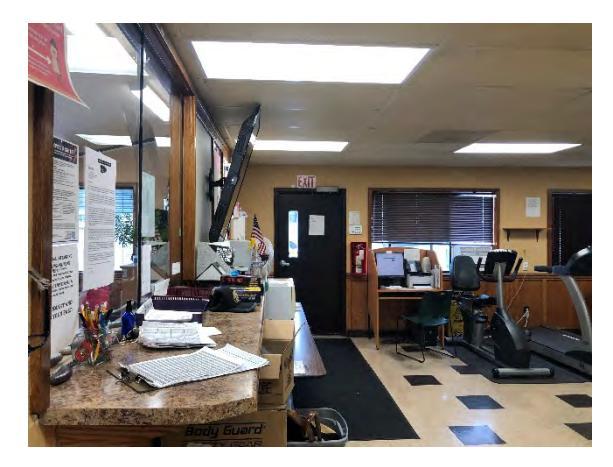
Dispatch Counter

The Operations office building is roughly 1,370 sf and constructed at an unknown year. The building has had an addition to the north side and interior renovations since originally constructed. Interior finishes range from carpet, vinyl flooring, suspended acoustic tile ceilings, and painted drywall. Finishes show typical wear for their age and in need of replacement. Several areas of existing vinyl flooring are worn and should be replaced. Doors are hollow metal with steel frames, in good condition. Exterior wood siding is worn and appears to have some drainage issues on the west side of the building.
